ROCK-FORD A's *MANIFOLD NEWS*

Give Me A "Brake" by Ron Lanquist

My Winter Project...and now it's Spring!

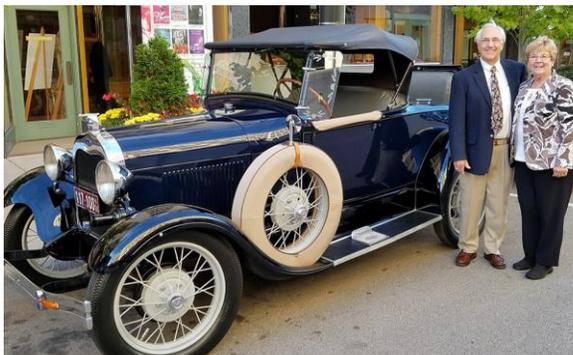
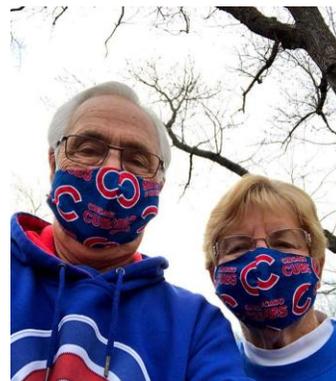
This year I chose to keep it simple. My goal was to remove the brake drums and then inspect and repack the bearings. After setting the "A" on jack stands, I removed the front drums. The bearings looked great as well as the brake shoes. I'm in! Jim Morley (mister parts man) came over with his rear hub tool. The drums came off easily. After prying out the lock-ring and seal, we found one of the bearings showing wear and scalding. New ones were ordered. When inspecting the brake linings, the rivets appeared to be too close. New linings were ordered as well as seals and such. We chose to do one side at a time to avoid re-assembly confusion. (I'm Swedish!) The rivets punched out easily which removed the lining from the shoes. Heating the linings allowed them to be shaped to the shoes easily. Re-riveting was also easy. The drums looked great and smooth. The shoes were then fit to the drums by sanding them with a belt sander (high tech). The brake assembly was re-installed. Then trouble began! The drums would not fit over the shoes... too tight! We removed the brake and emergency brake assembly again... then took the drum and shoes over to the Auto Clinic (Brad Stauffer). After getting a good laugh, he arched the shoes to the drums. Voila! ... the service shoes were reinstalled before installing the emergency brake assembly and the drum now fits over the shoes. We then completed the brakes on the opposite side. This time having the shoes properly fit to the drum and checking the fit prior to re-installing the emergency brake assembly. Maybe this is why I had problems with other projects?

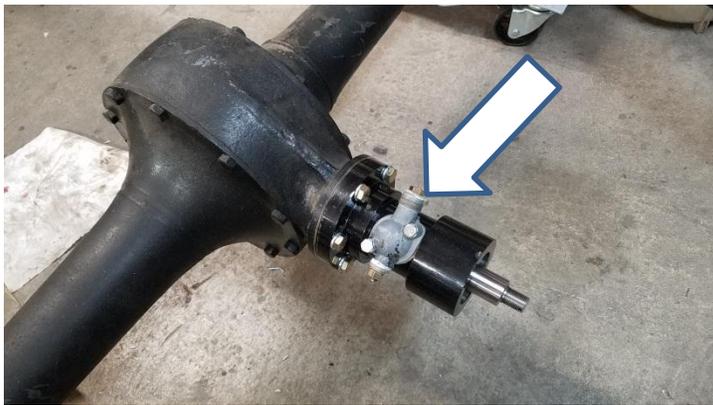
New pinion housing installed on rear end; the little gray item on top is the speedometer drive

So, in the mean time, to fill the time, I decided to buy and install a T5 Borg Warner transmission in the Ford. So I got the transmission from a place called A & B Salvage in South Beloit (AKA junk yard – and I really mean JUNK yard!) The transmission was in excellent shape and just needed cleaning. The installation kit came from a company called Transmission Exchange out of Monticello, Kentucky. The man who owns the business, Johnny Baker, was most helpful in supplying all the equipment I needed and all the advice I wanted. The installation didn't exactly go as planned – why would it?! Several things needed to be modified from the original plans, like the location of the brake cross shaft, the length of the brake rods, and a few small odds and ends to make it come out correctly. All in all, it was a pretty simple installation, and a great project for the winter, being that it was just completed today, April 17th! The pictures below will give you some idea of the end results. And a special thanks to Phil Hodges for all of his help!

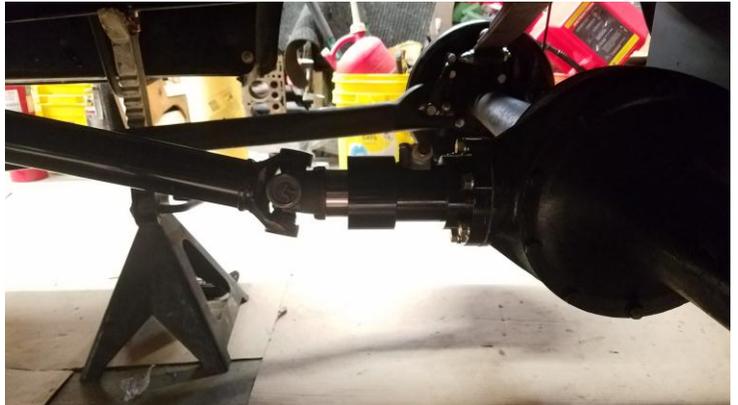
Drive shaft attached to the pinion shaft

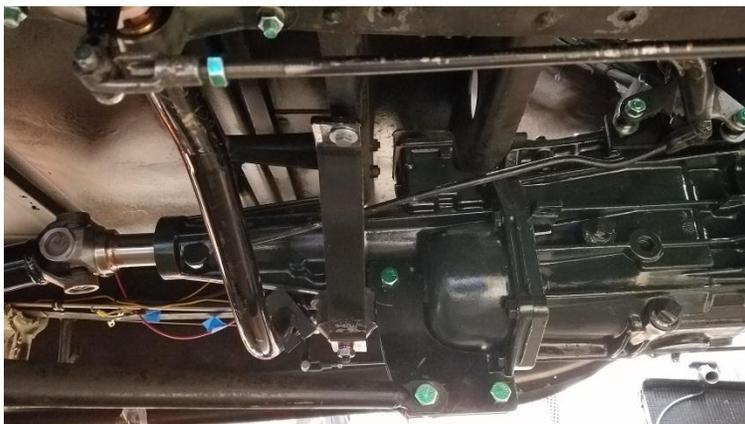
Transmission mounted under car; the brake cross shaft is mounted 1" forward of the E brake shaft

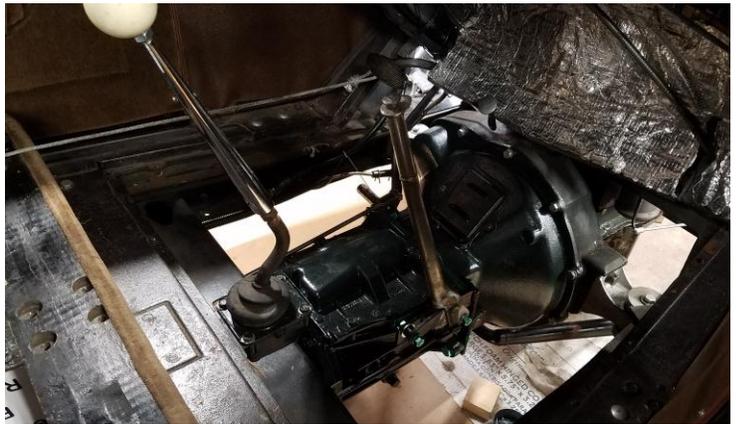
View of the transmission from the passenger seat
